NASA DoD -55°C to +125°C Thermal Cycle Test Results

Dave Hillman, Tim Pearson and Ross Wilcoxon
Rockwell Collins
Cedar Rapids IA

The objective of the study was to compare the solder joint integrity of selected lead-free solder alloys to Sn63/Pb37 solder alloy for a -55°C to +125°C temperature range in accordance with the IPC-9701 specification under various as-manufactured and reworked conditions.

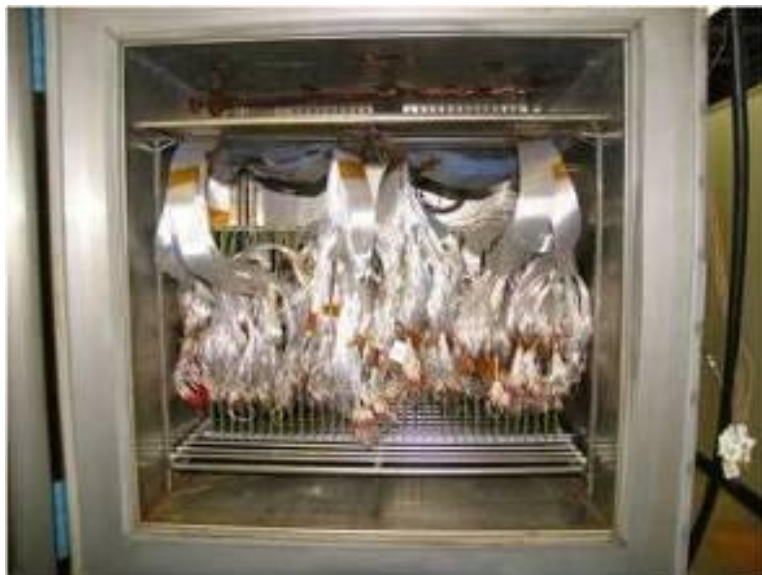
Figure 3: Test Vehicles in the Thermal Cycle Chamber
